**SCC NORTHWEST MANUFACTURING LTD.  
2008 CHRYSLER SEBRING SEATS WITH SCC NORTHWEST LTD  
SEAT COVERS  
STATIC AIRBAG DEPLOYMENT TEST SERIES**

### TEST REPORT

**MGA REPORT NO.:** C13I7-030.1  
**TEST(S) PERFORMED ON:** December 7, 2012  
**TEST DESCRIPTION:** Static Airbag Deployment  
**ITEM DESCRIPTION:** 2008 Chrysler Sebring with SCC Northwest Mfg. LTD. Seat Covers  
**PROCEDURE NUMBER:** MGATP\_SAD  
09/18/12  
**TEST REFERENCE  
NUMBER(S):** P21497-P21499  
**TEST LABORATORY:** MGA Research Corporation  
446 Executive Drive  
Troy, Michigan 48083  
**SUBMITTED TO:** Steven Koyama  
SCC Northwest Manufacturing LTD.  
1330 William Street  
Vancouver, BC V5L 2P5  
**REPORT DATE:** December 10, 2012  
**MGA PERSONNEL:**

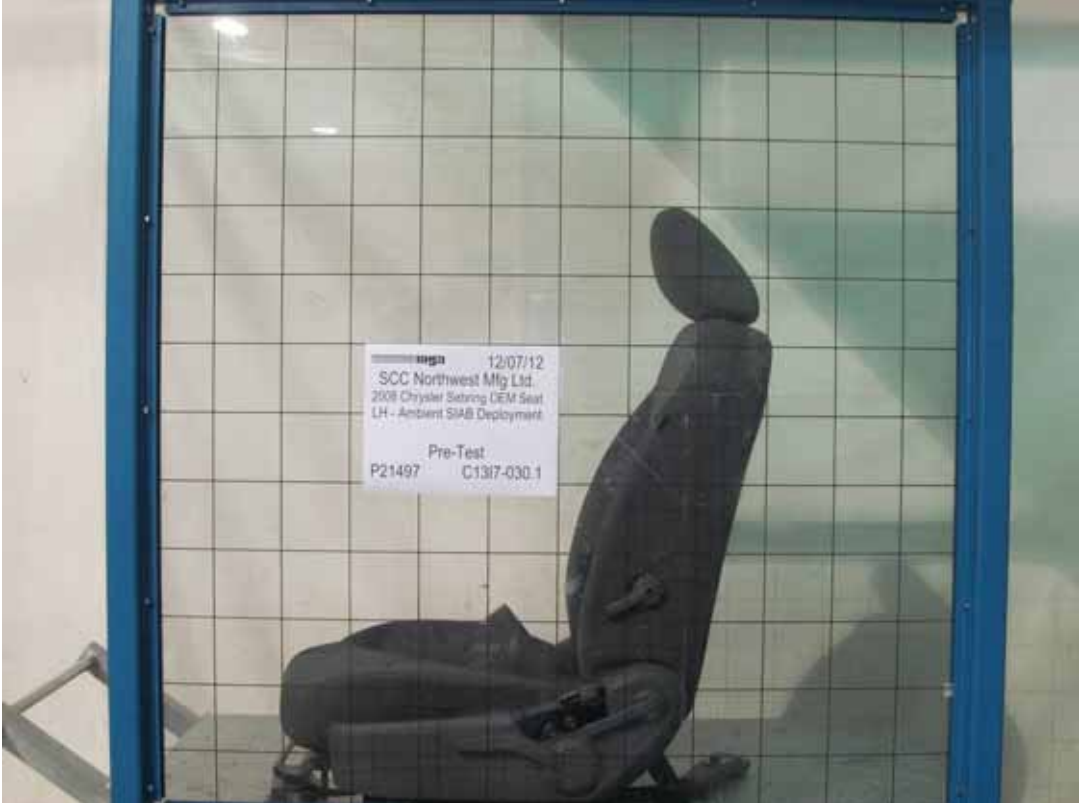
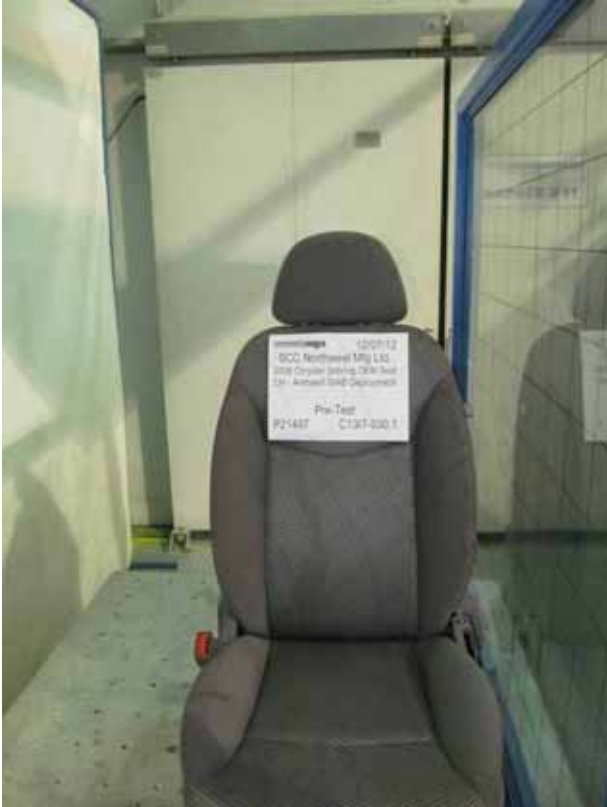
Pre-Test Photo #1 of Test #P21497

Pre-Test Photo #2 of Test #P21497

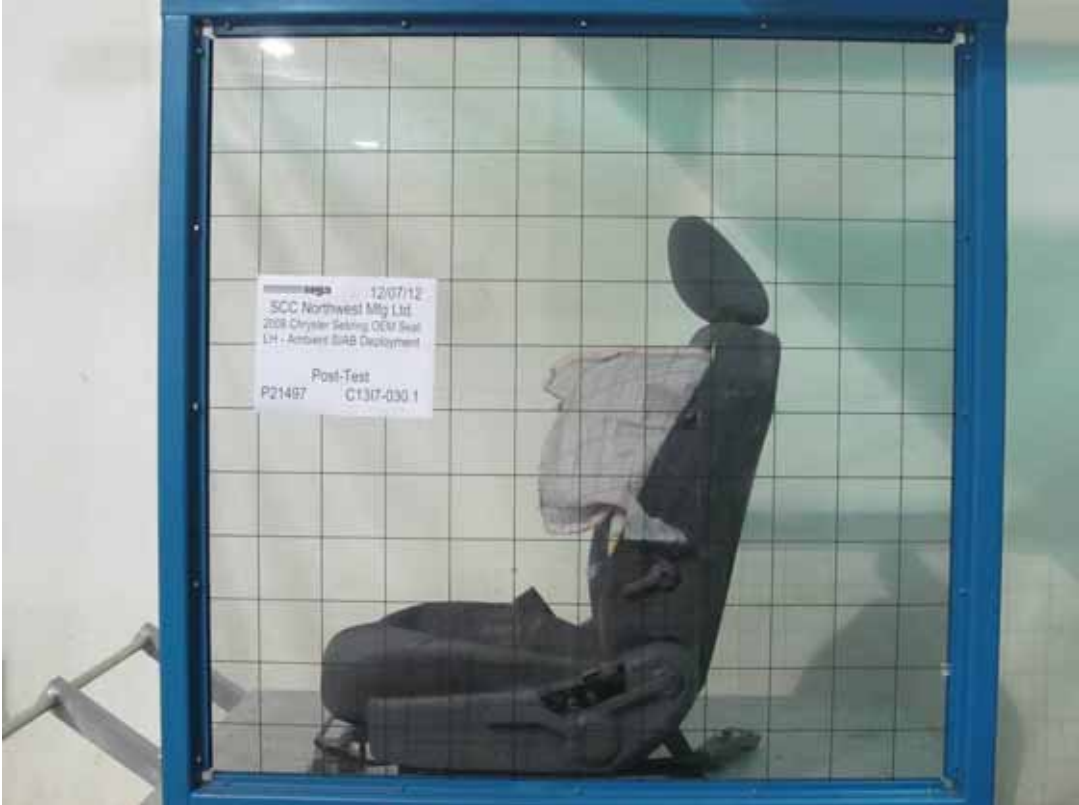
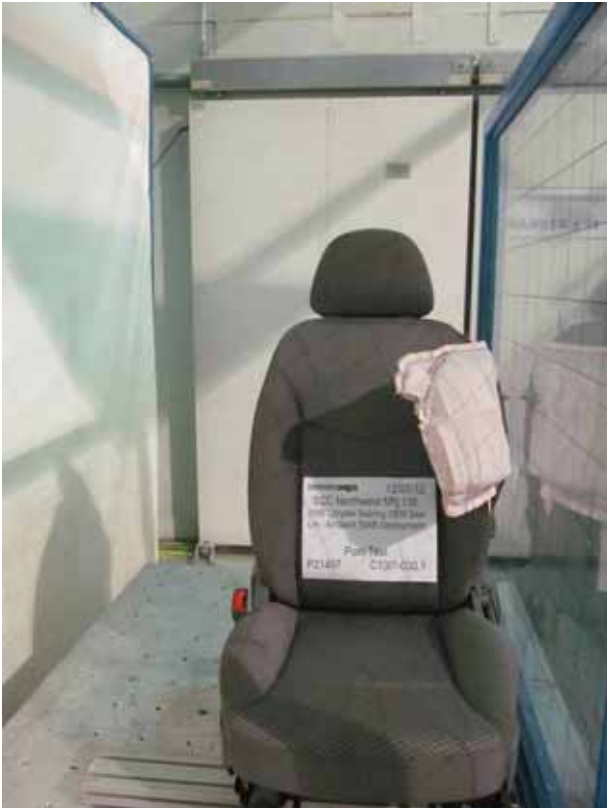
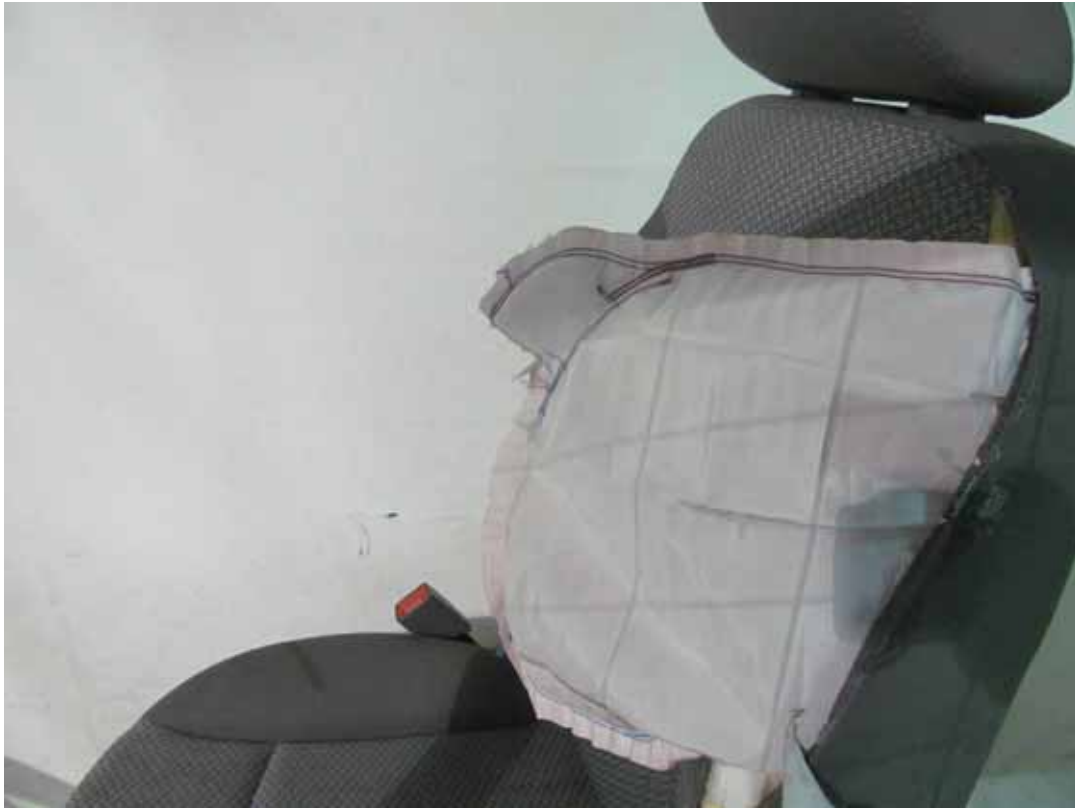
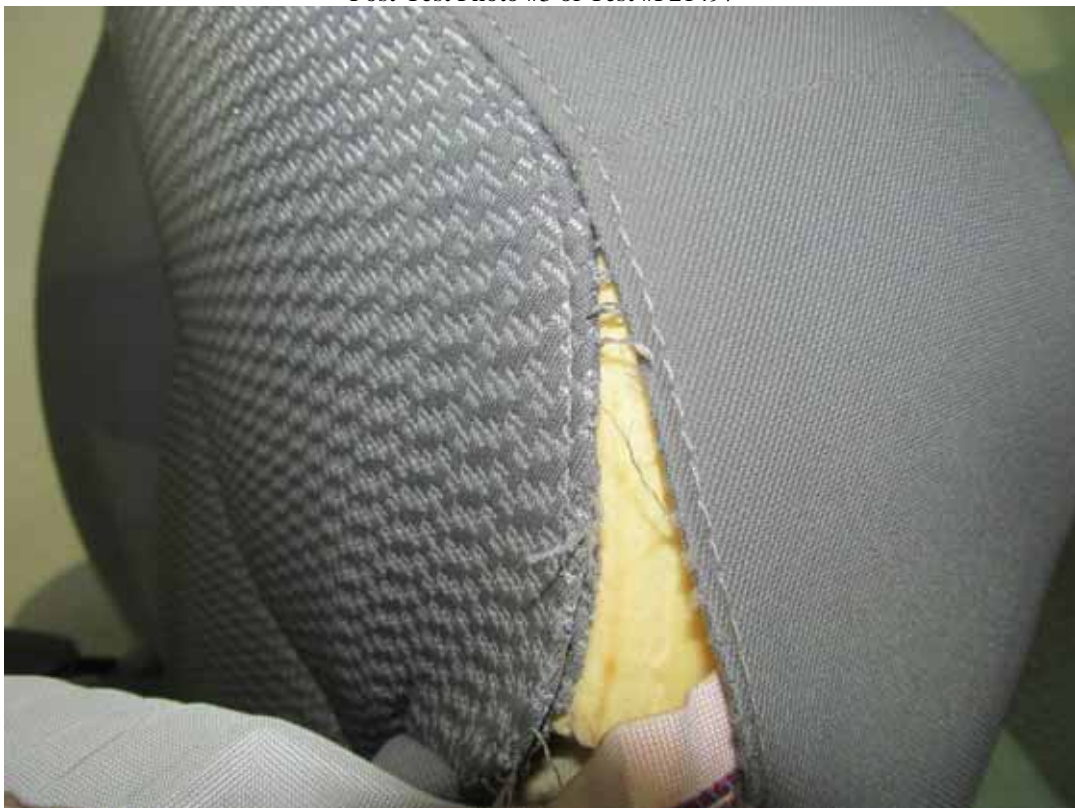
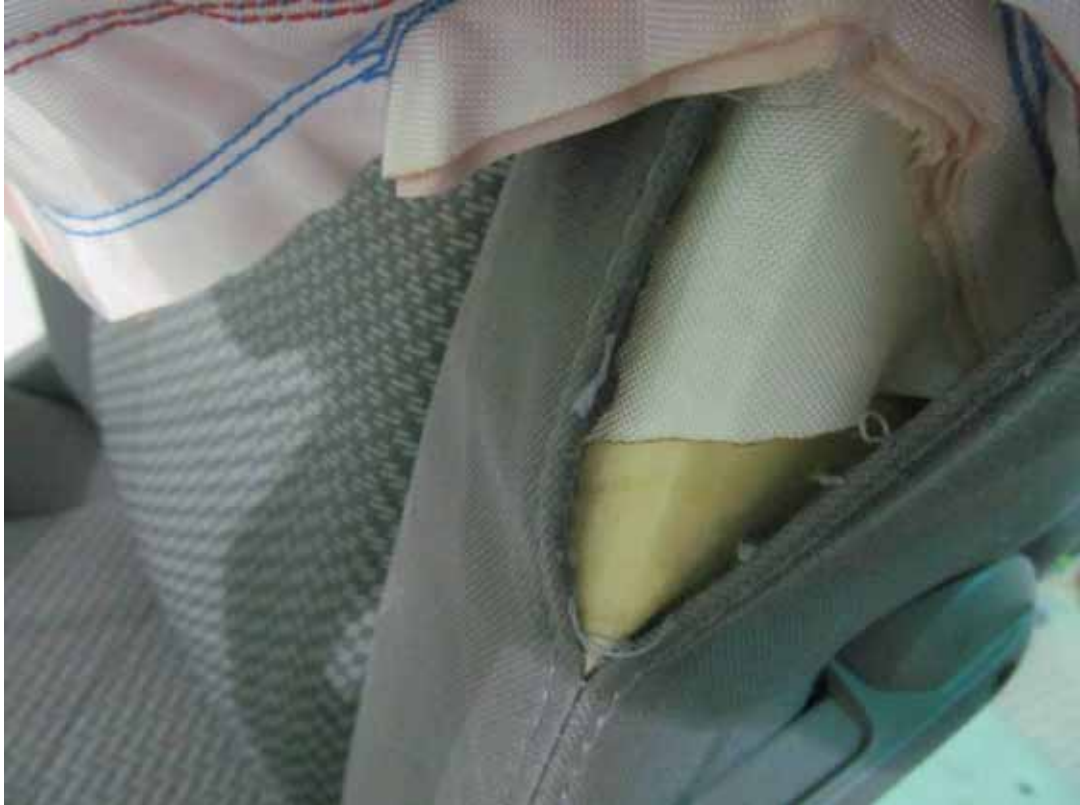
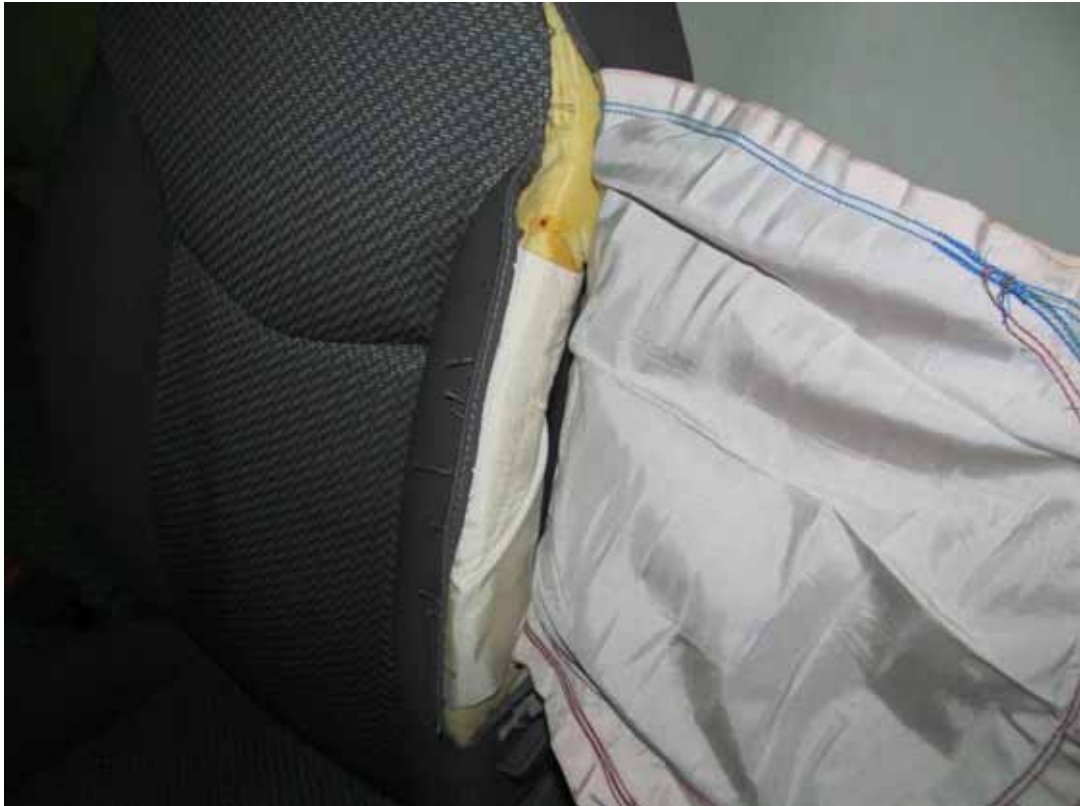
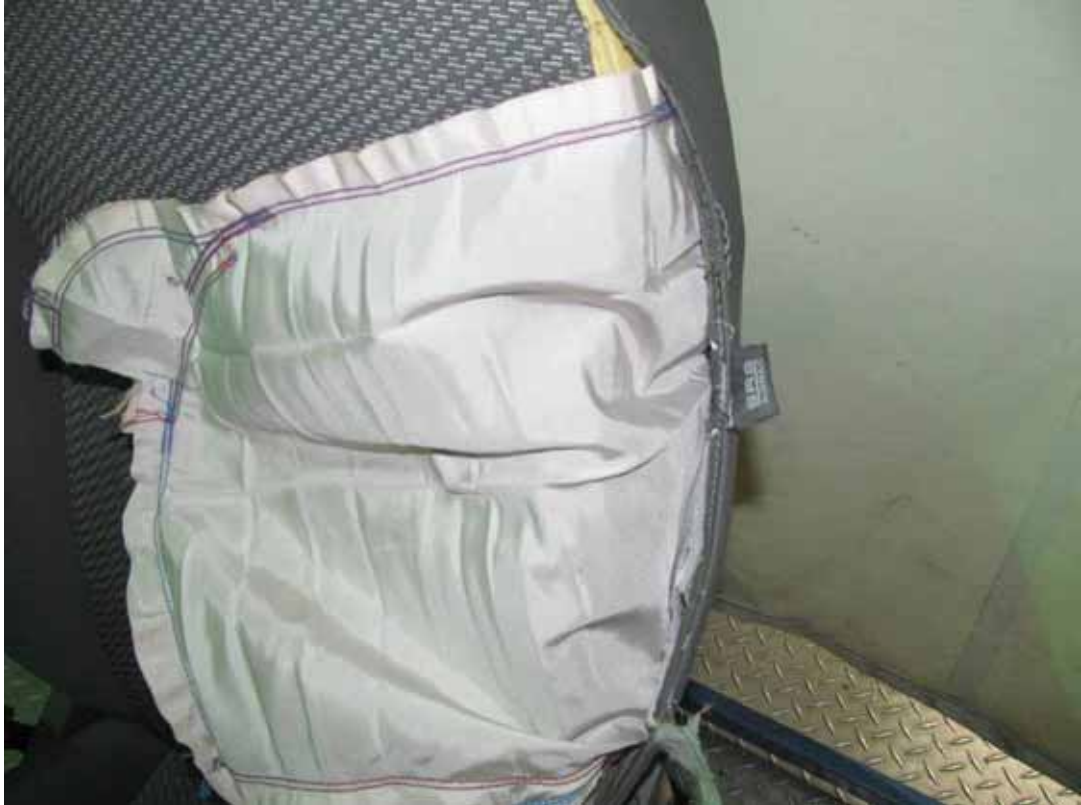
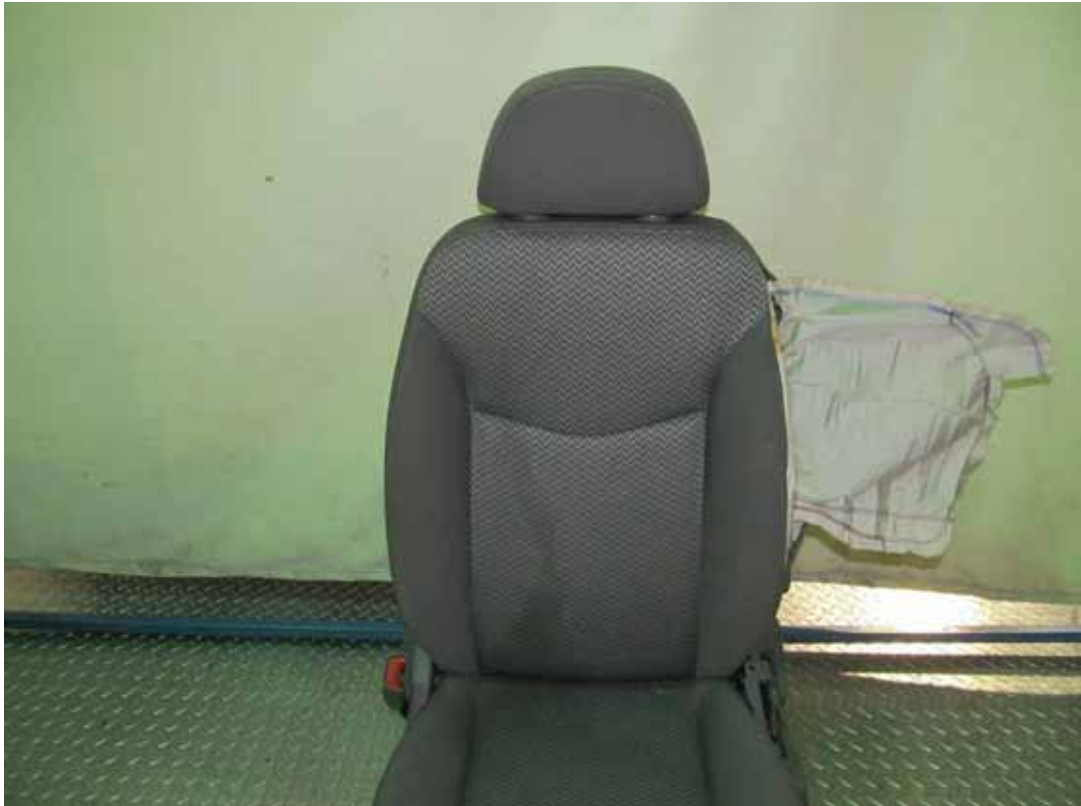
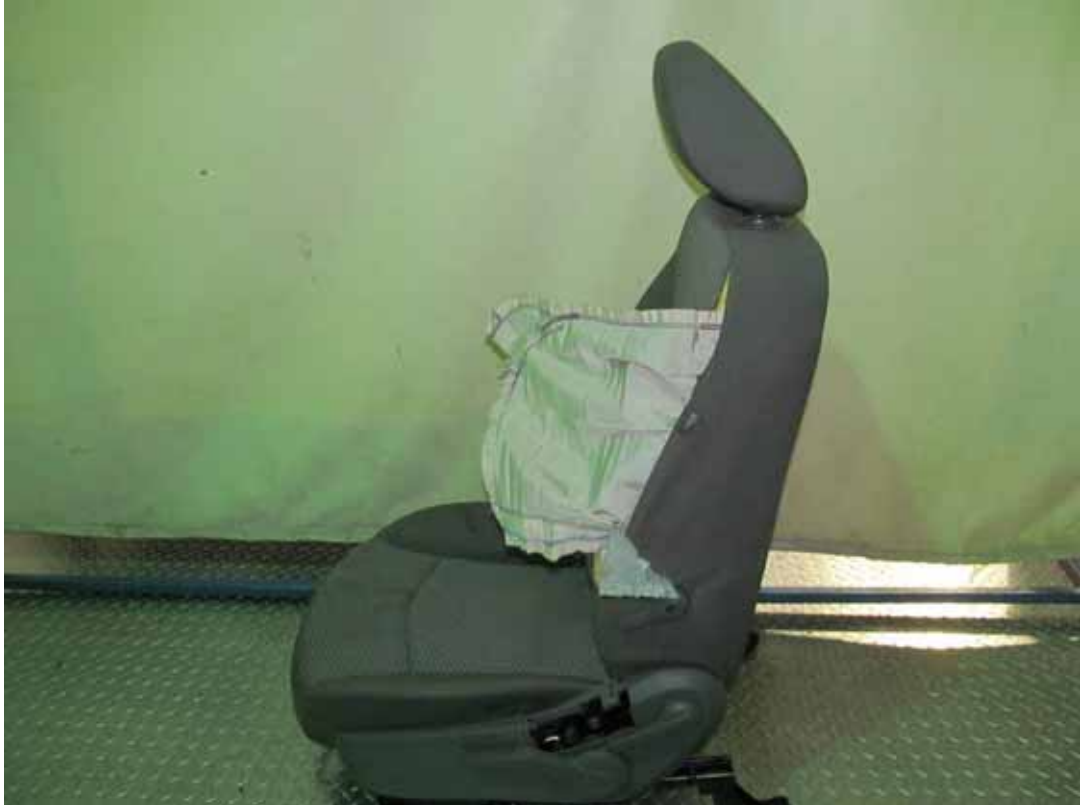
Post-Test Photo #1 of Test #P21497

Post-Test Photo #2 of Test #P21497

Post-Test Photo #3 of Test #P21497

Post-Test Photo #4 of Test #P21497

Post-Test Photo #5 of Test #P21497

Post-Test Photo #6 of Test #P21497

Post-Test Photo #7 of Test #P21497

Post-Test Photo #8 of Test #P21497

Post-Test Photo #9 of Test #P21497

| MGA Test No. | Date | Sample | Temperature (°C) | Breakout Time (ms) | Full Inflation Time (ms) | Post-Test Comments |
|---|---|---|---|---|---|---|
| P21497 | 12/7/2012 | OEM Seat (Baseline) | 22.1 | 2.50 | 7.50 | •Airbag deployed<br>•No visible damage |

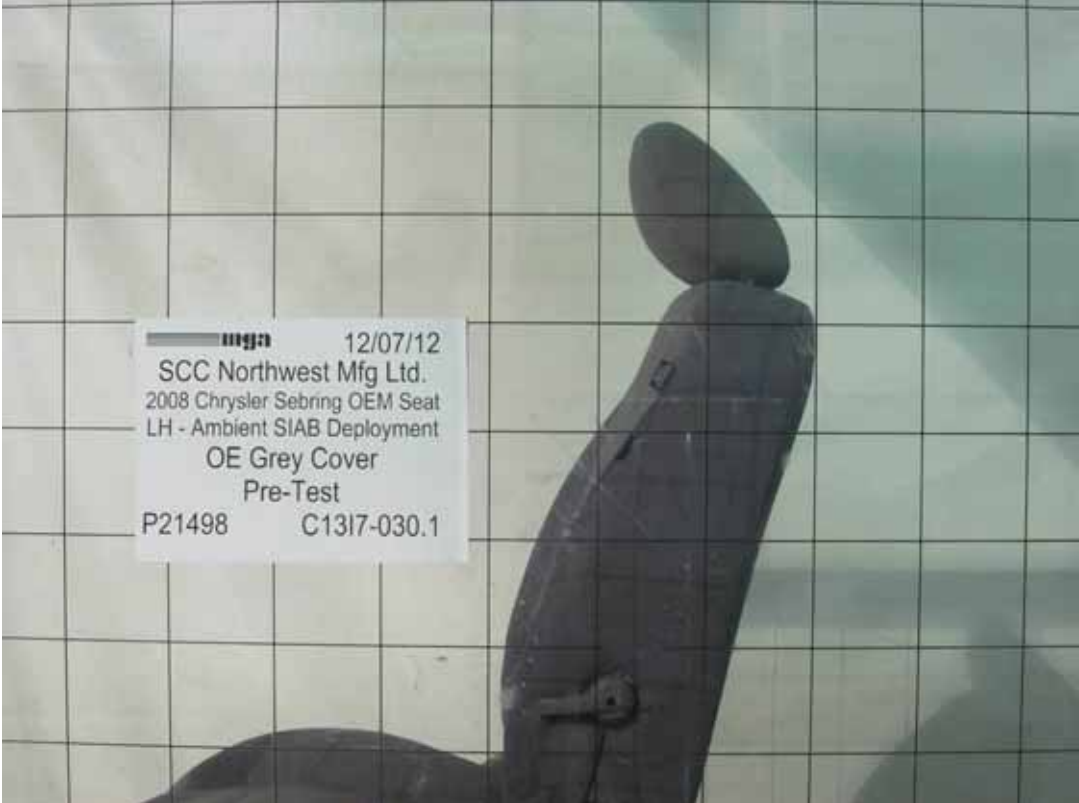
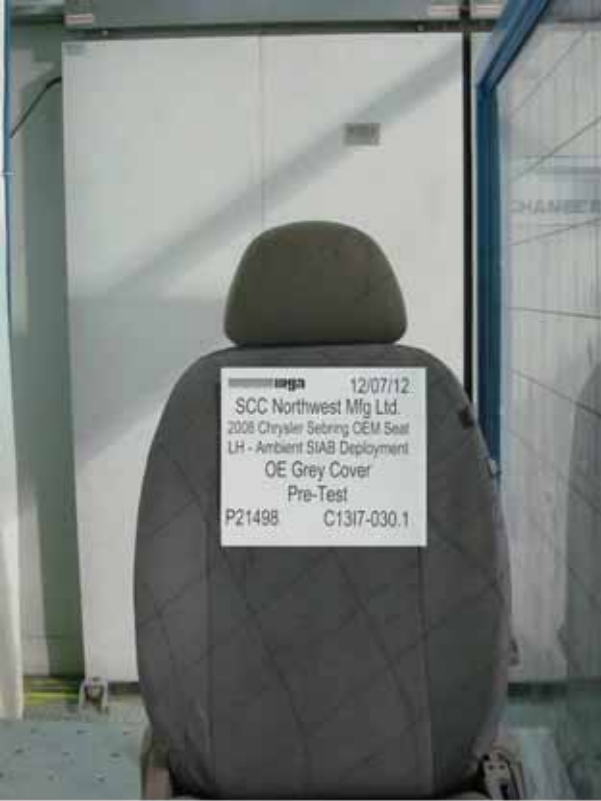
Pre-Test Photo #1 of Test #P21498

Pre-Test Photo #2 of Test #P21498

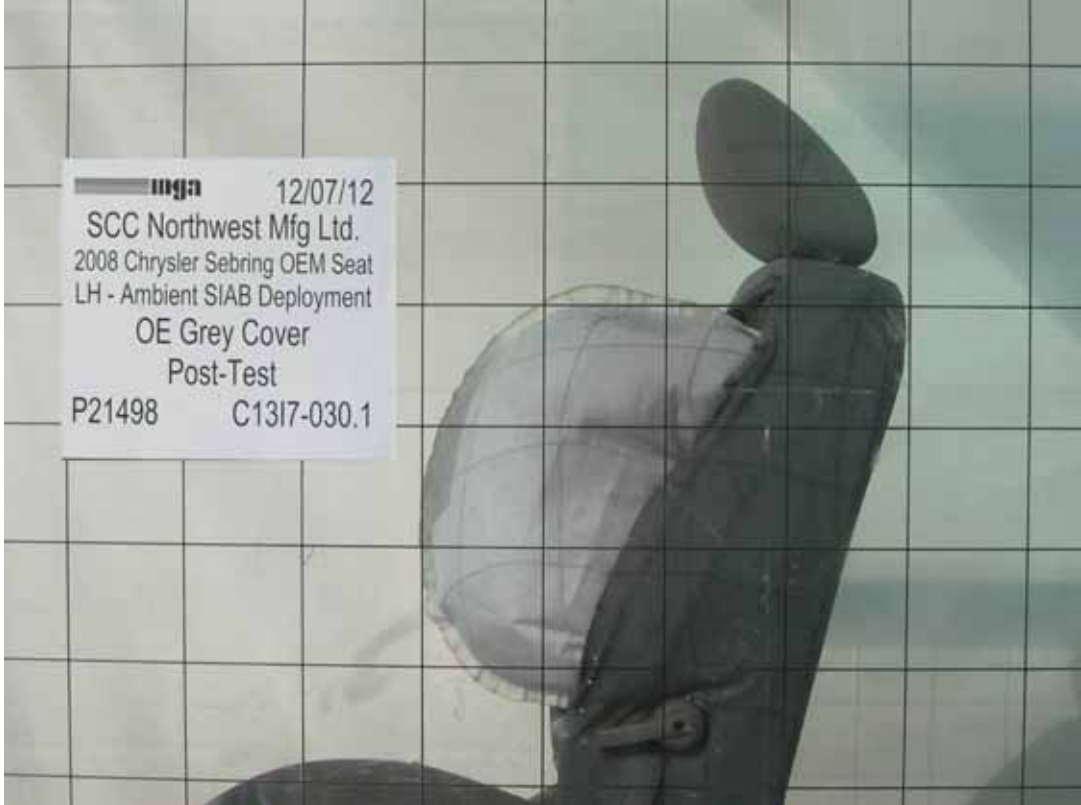
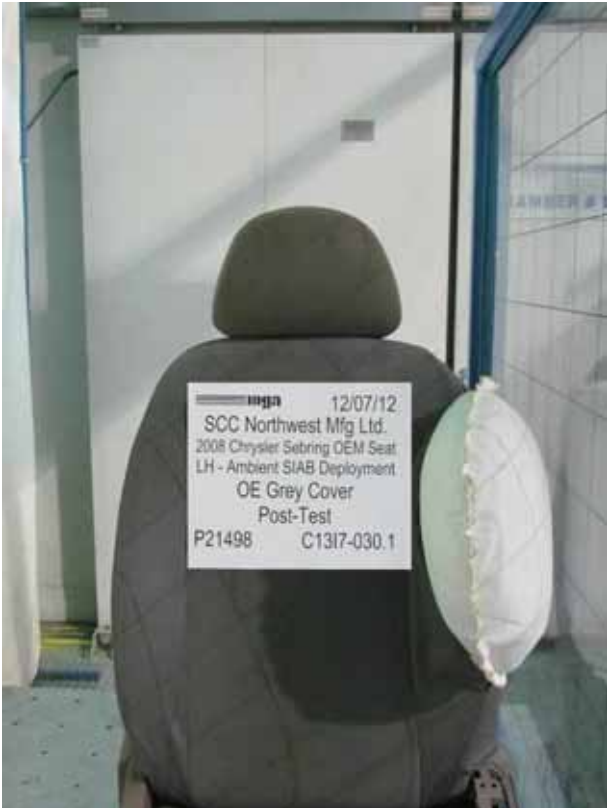
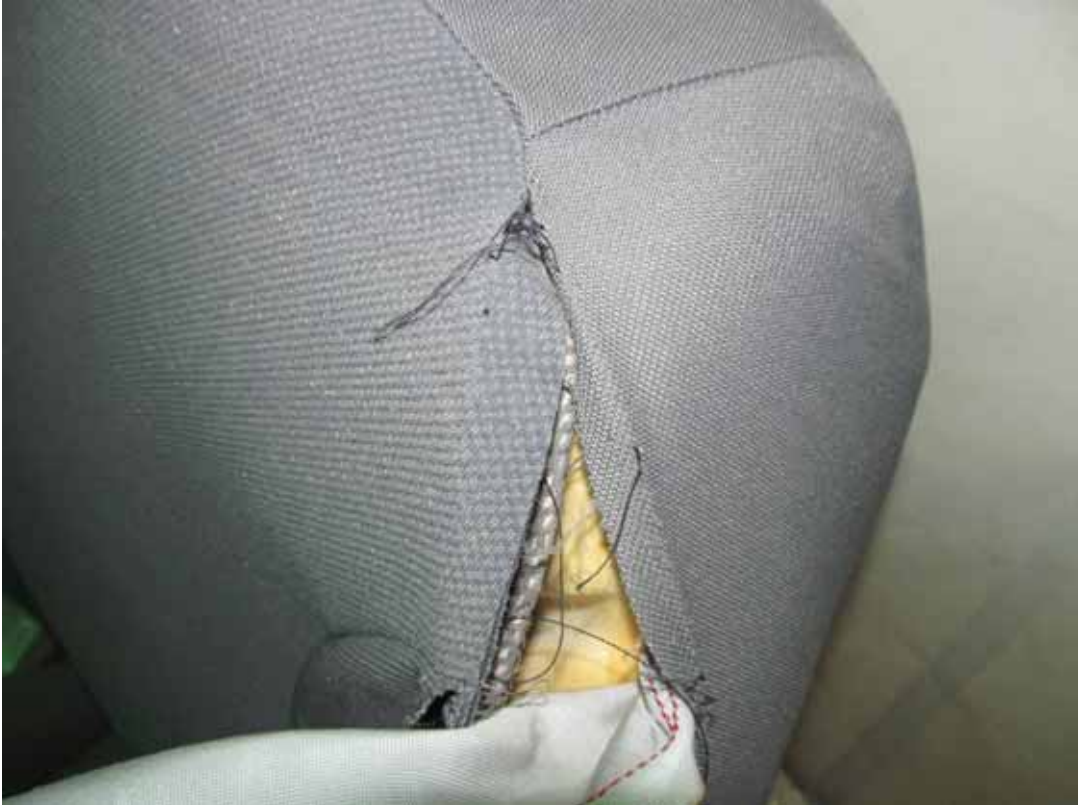
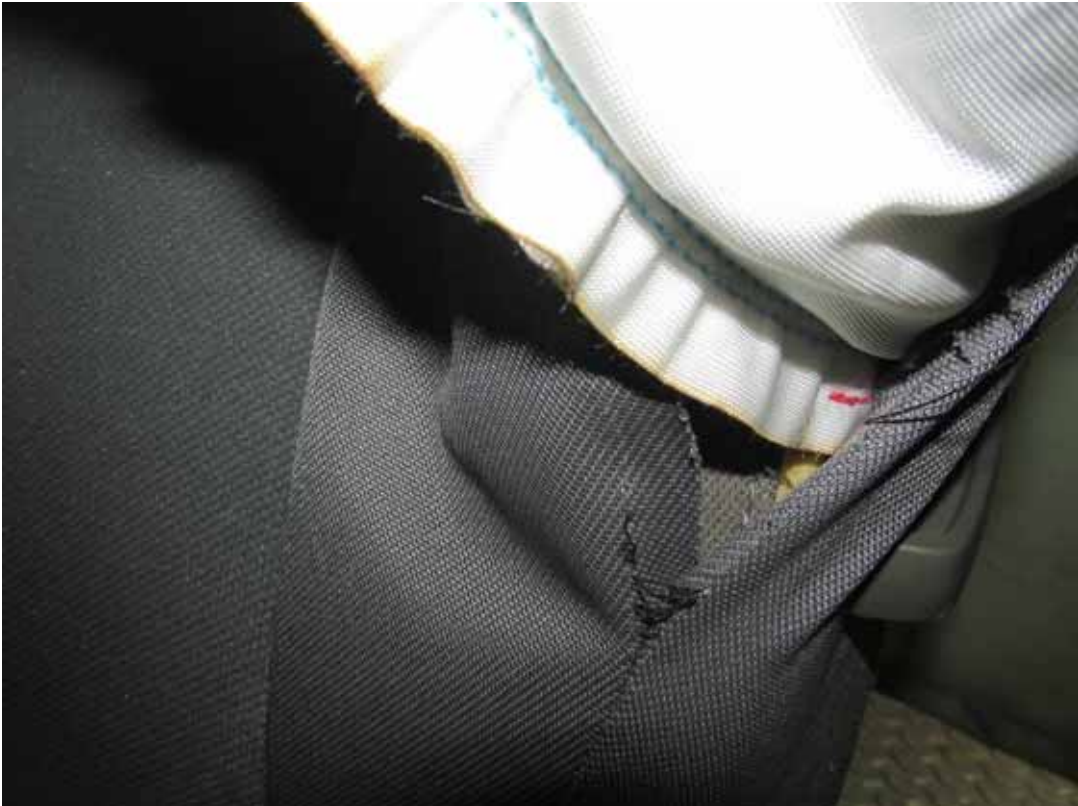
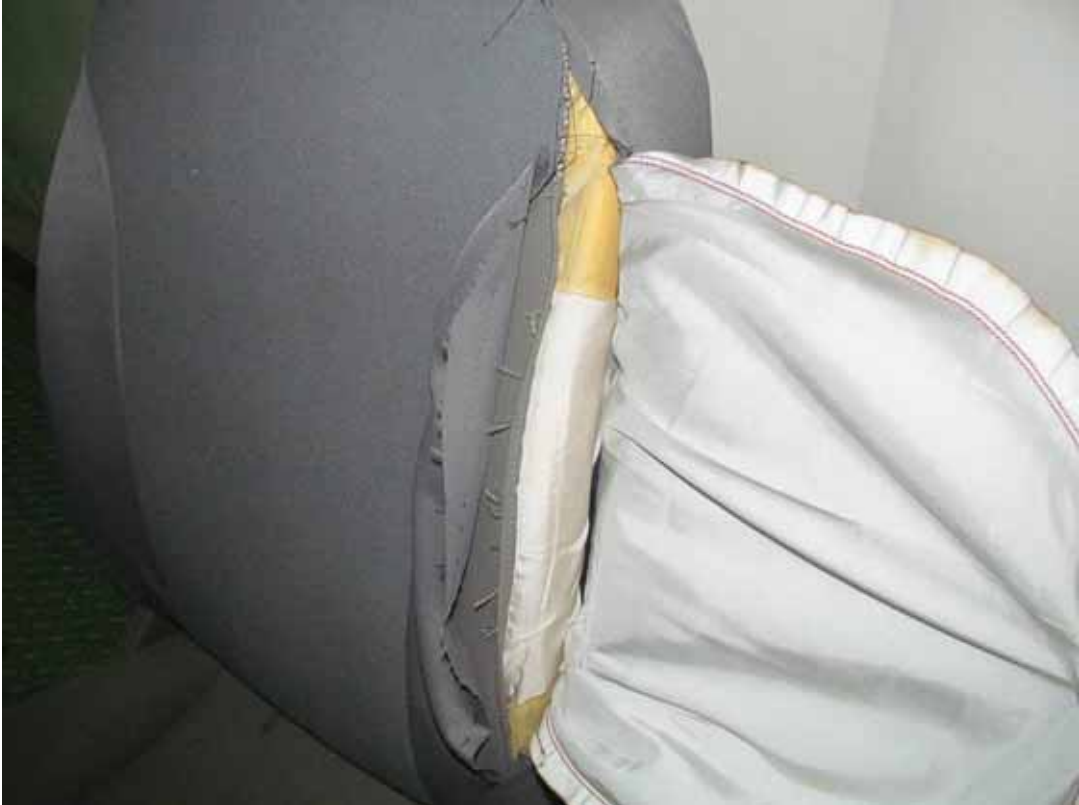
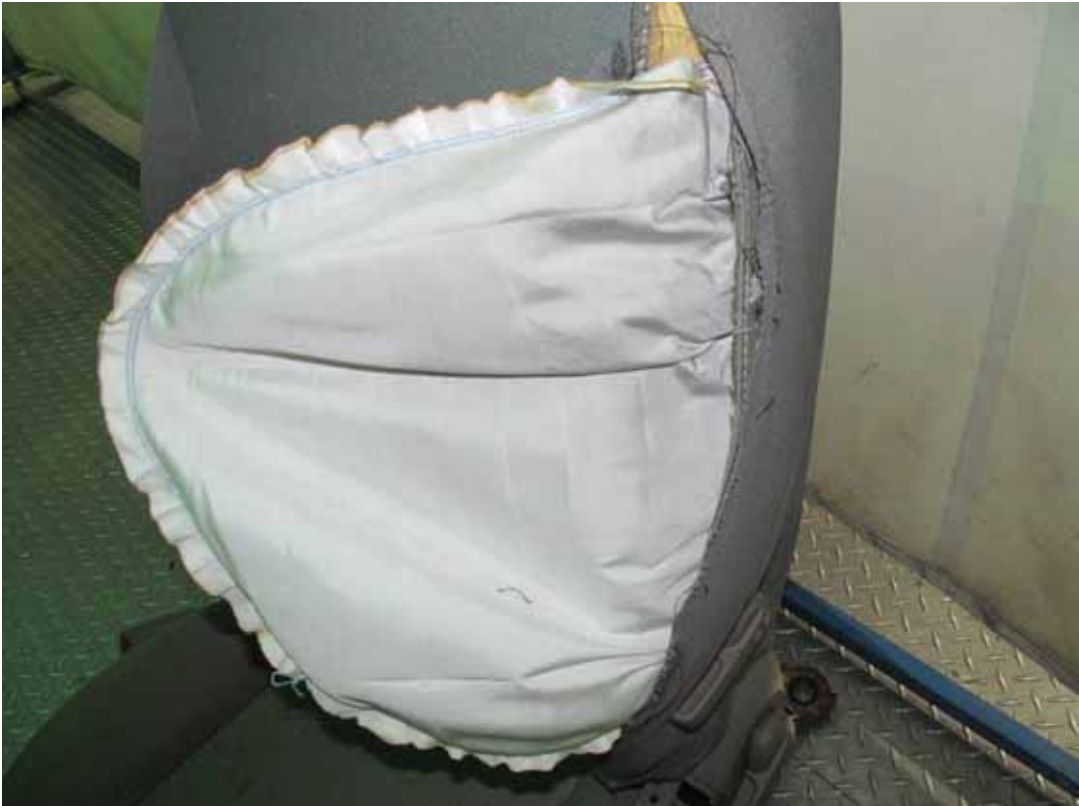
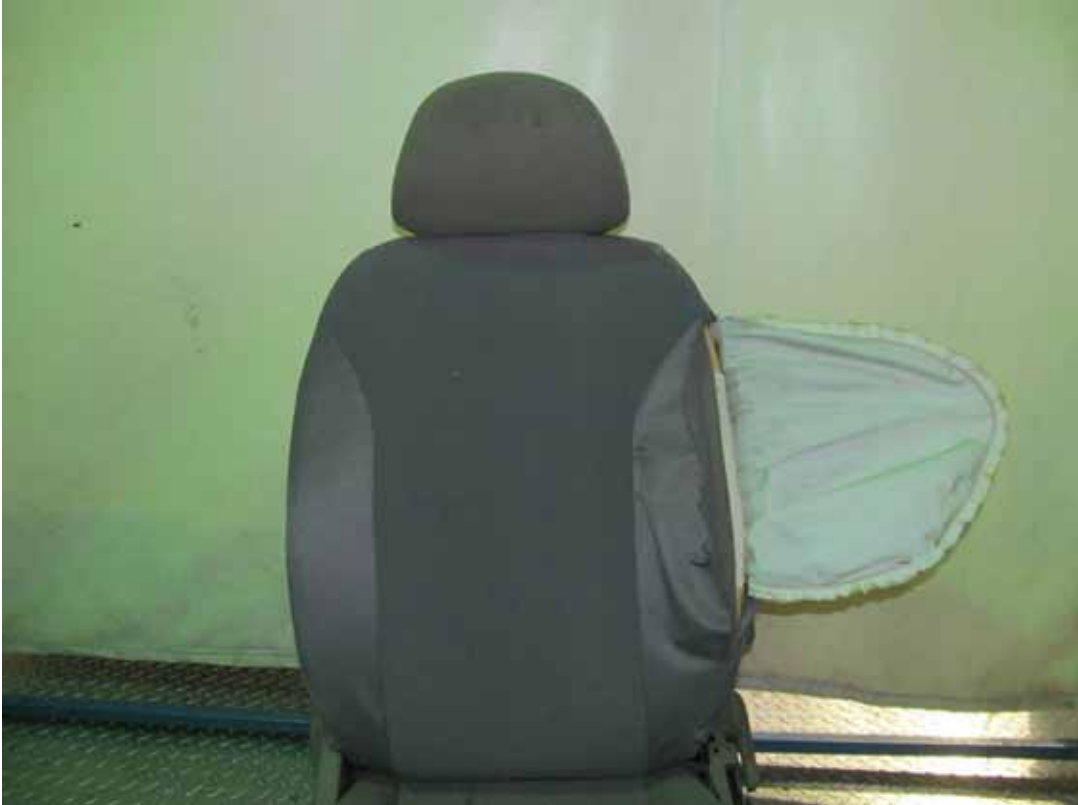
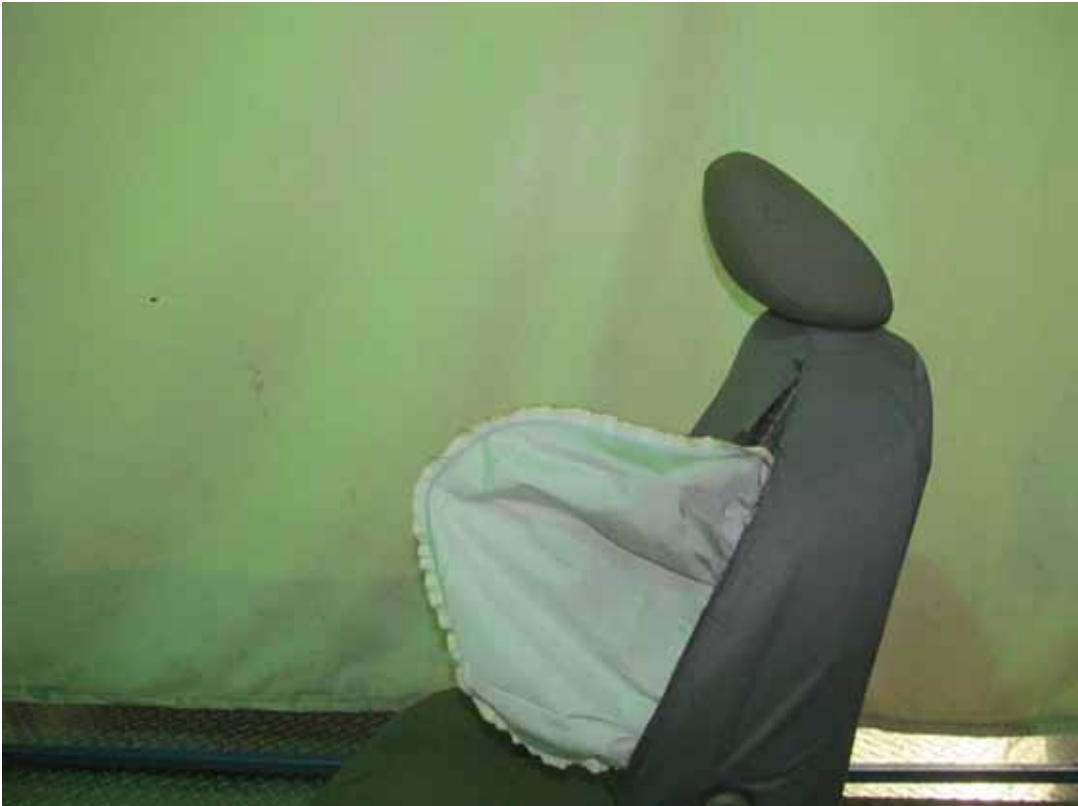
Post-Test Photo #1 of Test #P21498

Post-Test Photo #2 of Test #P21498

Post-Test Photo #3 of Test #P21498

Post-Test Photo #4 of Test #P21498

Post-Test Photo #5 of Test #P21498

Post-Test Photo #6 of Test #P21498

Post-Test Photo #7 of Test #P21498

Post-Test Photo #8 of Test #P21498

| MGA Test No. | Date | Sample | Temperature (°C) | Breakout Time (ms) | Full Inflation Time (ms) | Post-Test Comments |
|---|---|---|---|---|---|---|
| P21498 | 12/7/2012 | OE Grey Cover | 22.3 | 3.50 | 7.50 | •Airbag deployed<br>•Airbag labels came off during deployment |

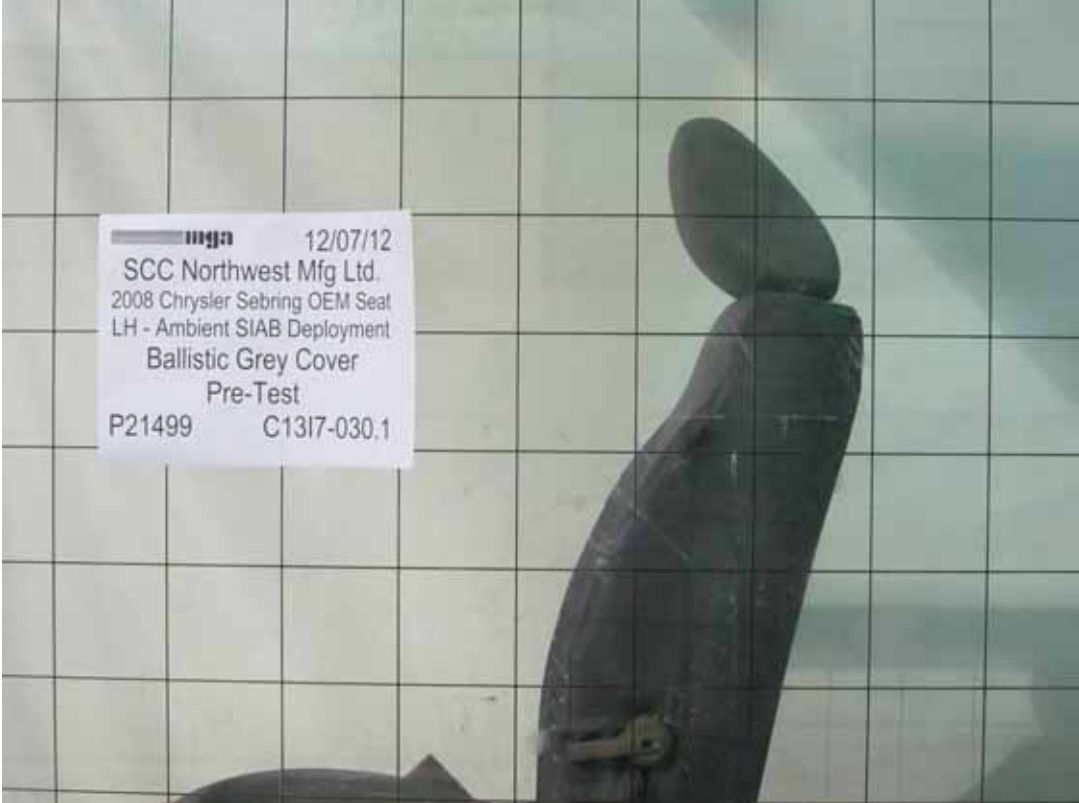
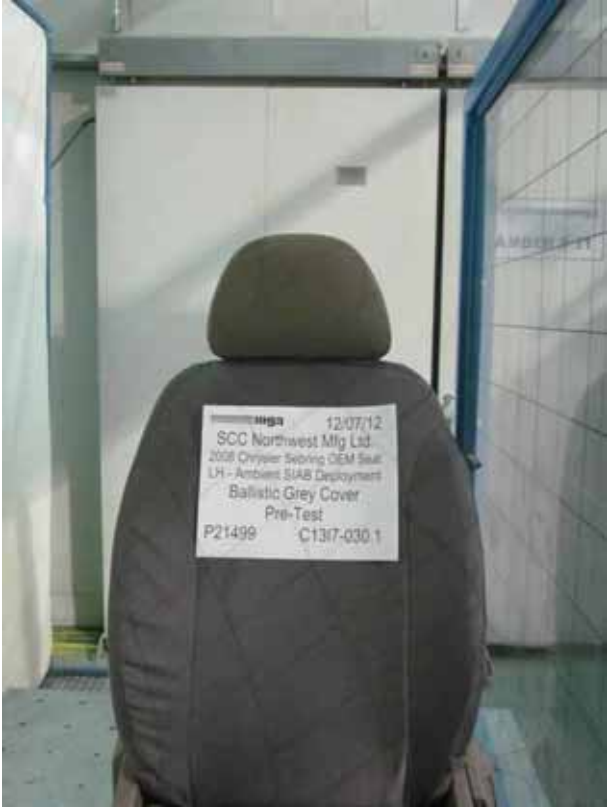
Pre-Test Photo #1 of Test #P21499

Pre-Test Photo #2 of Test #P21499
