**SCC NORTHWEST MANUFACTURING LTD.  
2008 CHRYSLER SEBRING SEATS WITH SCC NORTHWEST LTD  
SEAT COVERS  
STATIC AIRBAG DEPLOYMENT TEST SERIES**

### TEST REPORT

**MGA REPORT NO.:** C13I7-030.1  
**TEST(S) PERFORMED ON:** December 7, 2012  
**TEST DESCRIPTION:** Static Airbag Deployment  
**ITEM DESCRIPTION:** 2008 Chrysler Sebring with SCC Northwest Mfg. LTD. Seat Covers  
**PROCEDURE NUMBER:** MGATP\_SAD  
09/18/12  
**TEST REFERENCE  
NUMBER(S):** P21497-P21499  
**TEST LABORATORY:** MGA Research Corporation  
446 Executive Drive  
Troy, Michigan 48083  
**SUBMITTED TO:** Steven Koyama  
SCC Northwest Manufacturing LTD.  
1330 William Street  
Vancouver, BC V5L 2P5  
**REPORT DATE:** December 10, 2012  
**MGA PERSONNEL:**

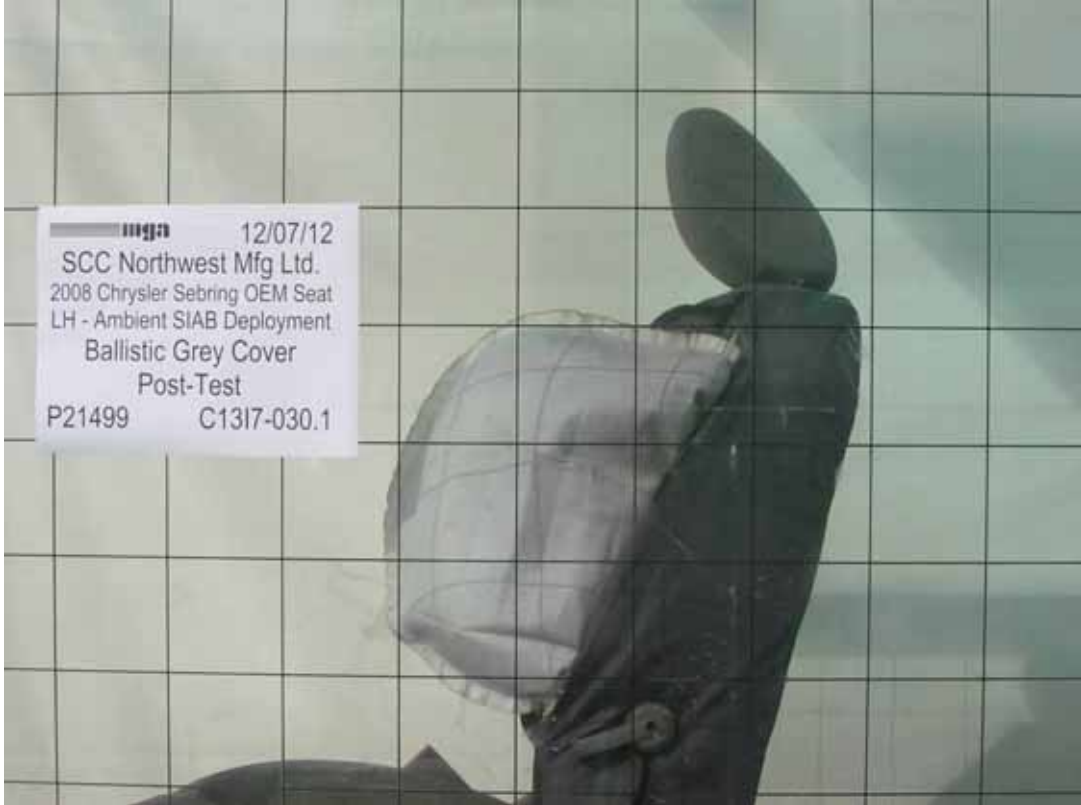
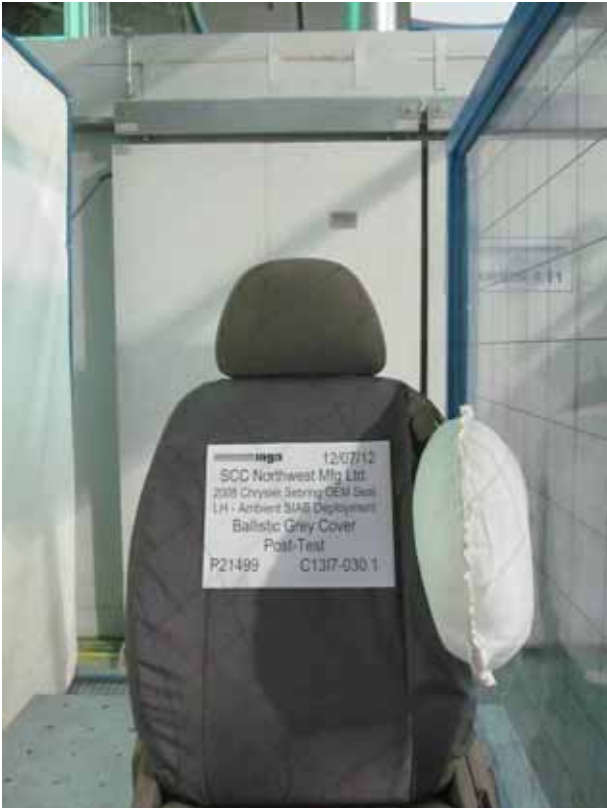
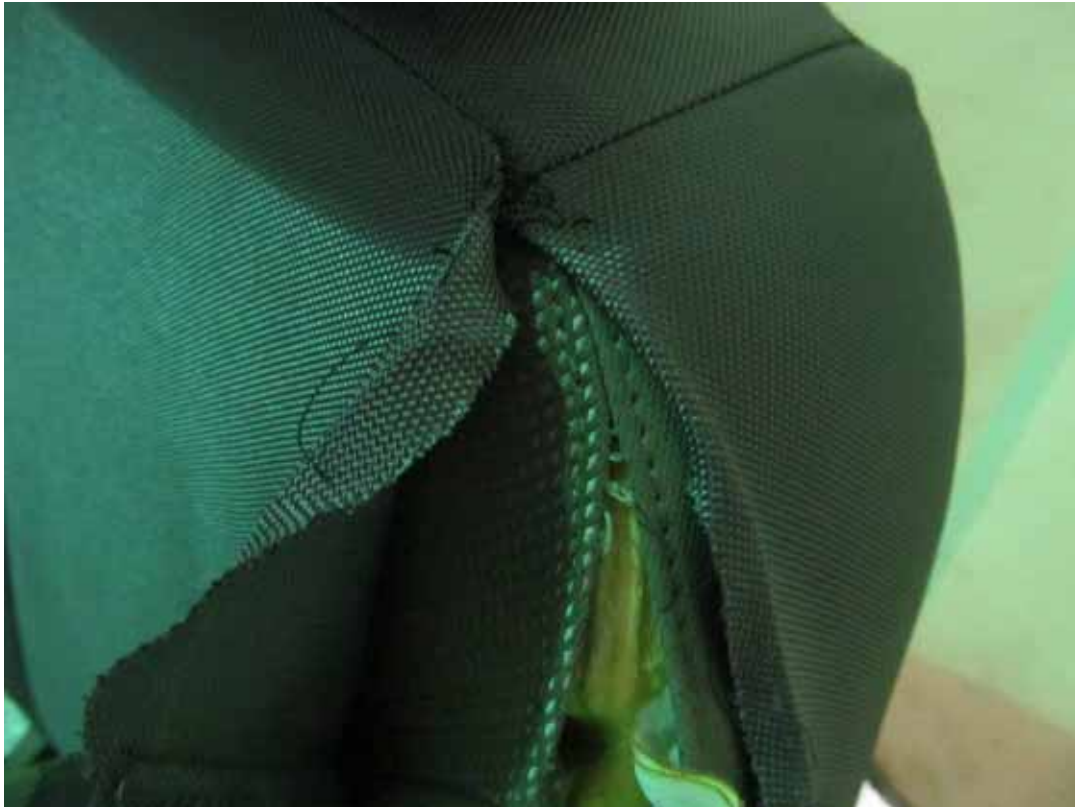
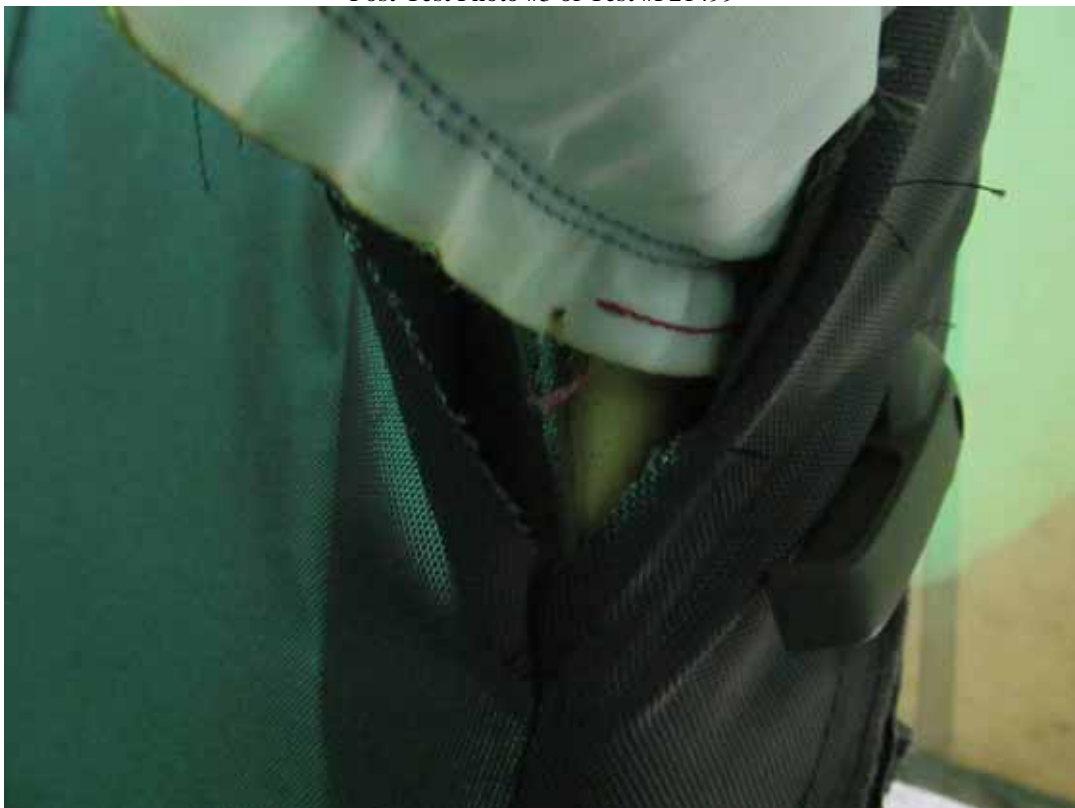
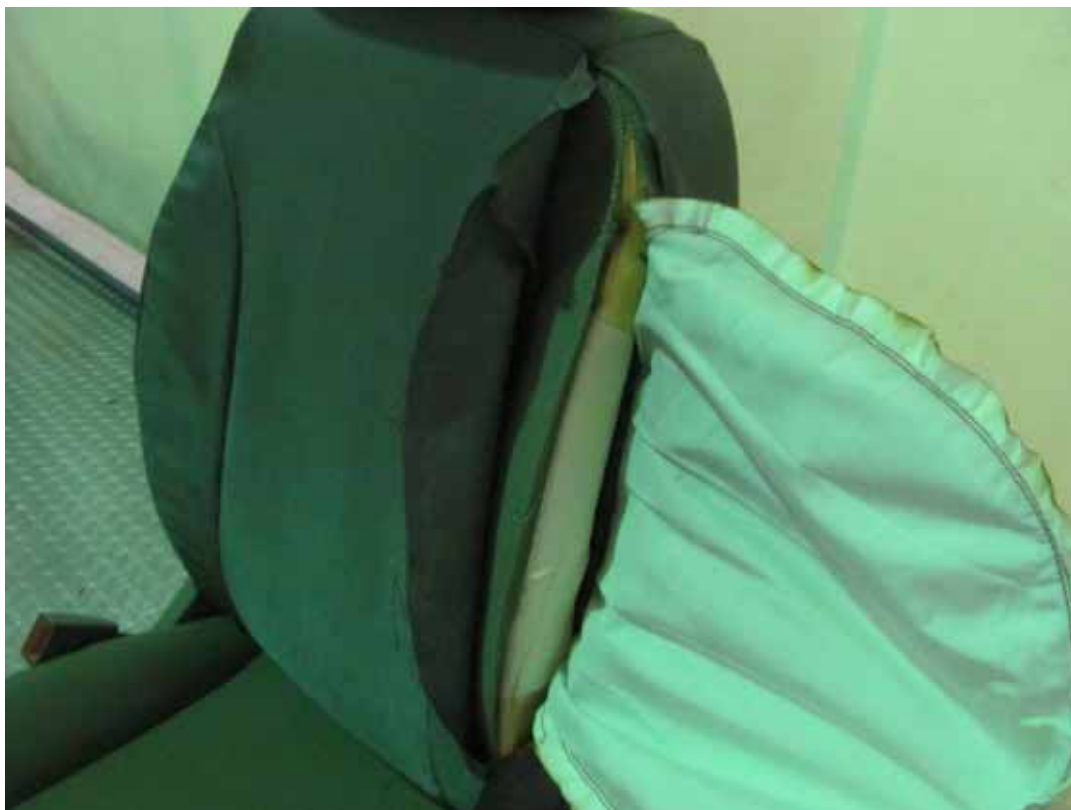
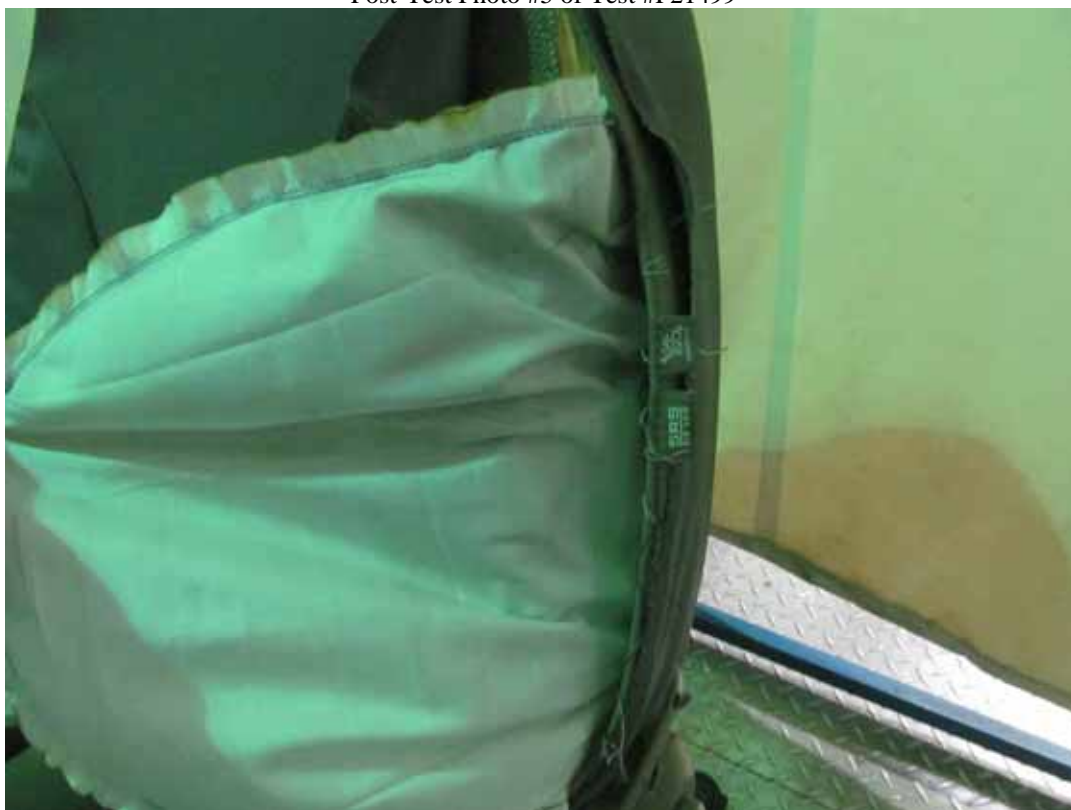
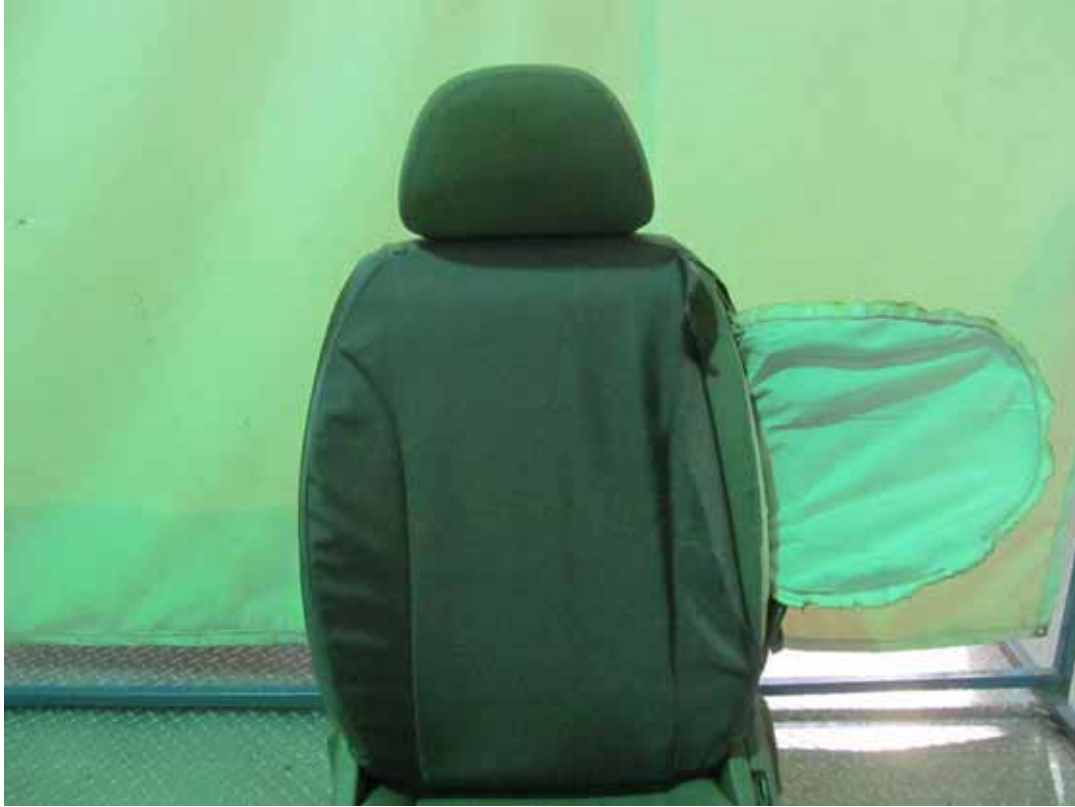
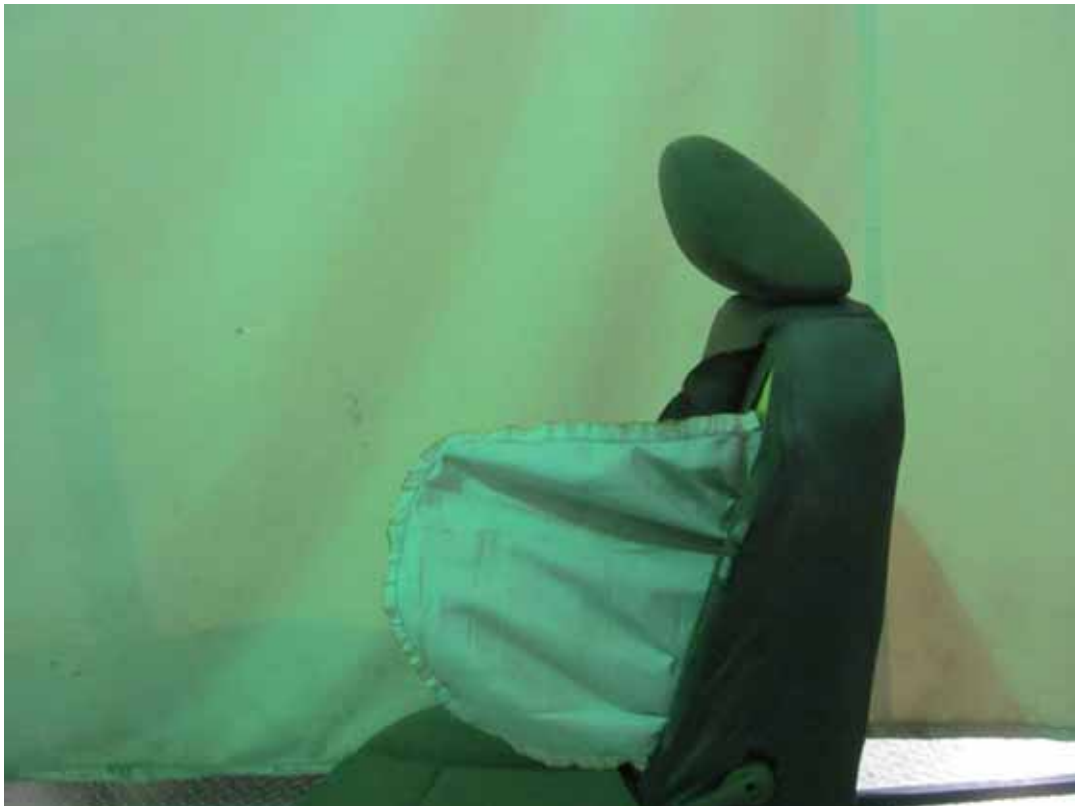
Post-Test Photo #1 of Test #P21499

Post-Test Photo #2 of Test #P21499

Post-Test Photo #3 of Test #P21499

Post-Test Photo #4 of Test #P21499

Post-Test Photo #5 of Test #P21499

Post-Test Photo #6 of Test #P21499

Post-Test Photo #7 of Test #P21499

Post-Test Photo #8 of Test #P21499

| MGA Test No. | Date | Sample | Temperature (°C) | Breakout Time (ms) | Full Inflation Time (ms) | Post-Test Comments |
|---|---|---|---|---|---|---|
| P21499 | 12/7/2012 | Ballistic Grey Cover | 22.2 | 3.00 | 7.00 | •Airbag deployed<br>•Airbag labels came off during deployment |
